Technical Report M-304  
December 1981

FAILURE ANALYSIS OF EPOXY-LINED  
ASBESTOS-CEMENT PIPE

20. ABSTRACT (Continue on reverse side if necessary and identify by block number)  This report presents the findings of an investigation into the causes of failure or epoxy lining in asbestos-cement sewer pipe used in certain Middle East construction projects.  The asbestos-cement pipe passed all tests performed on it to see whether it met the original specifications. The epoxy lining did not meet the requirements in some samples.

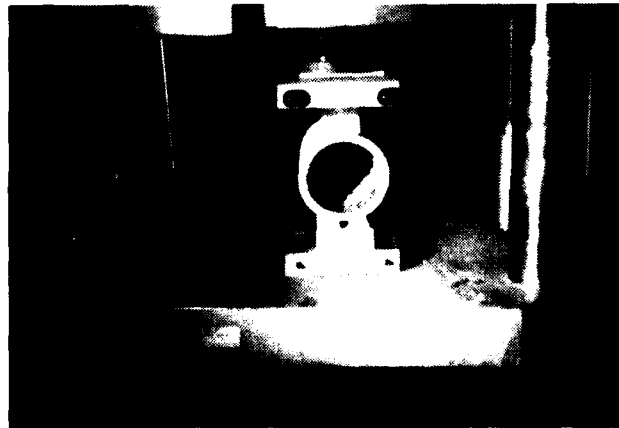
**Figure 1.** Crushing strength setup.

Summary of Results: all in-service and original pipe specimens tested exceeded the crushing strength minimum requirements.

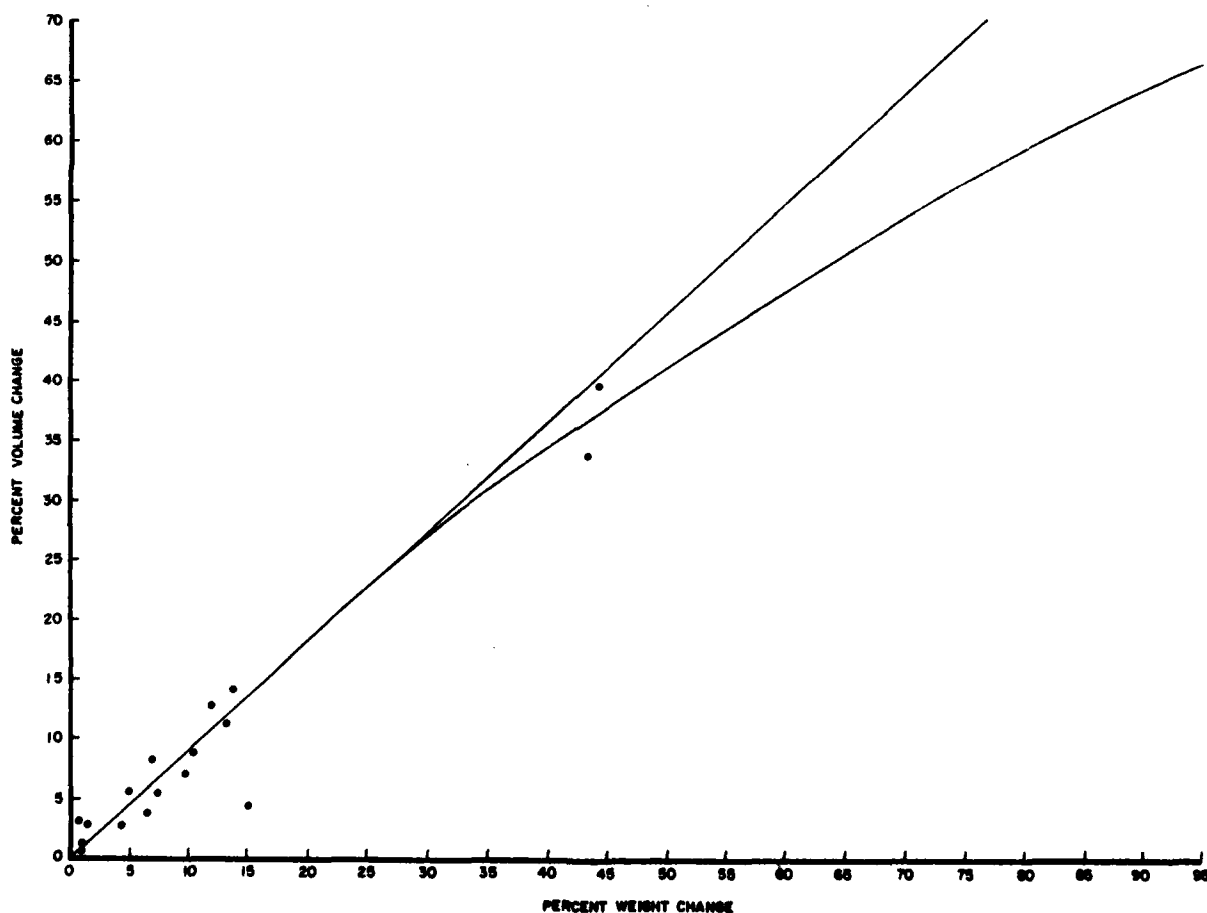
Figure 2. Percent weight change versus percent volume change of epoxy lining material.

The effects of the four "solvents" or swelling agents can be seen in Tables 7 through 10. The lining material showed different amounts of resistance to the four reagents used, and the results agreed well with Potter.<sup>15</sup> Swelling and weight gain are time dependent, as indicated by the 7- and 30-day results. Acidic media cause much more swelling than does a neutral or an alkaline medium. Acetic acid had a very pronounced effect on some lining materials. Table 11 shows the volume change associated with exposure to the test media.

all within the same medium. The variation of swelling from specimen set to specimen set shows the drastic differences in the resistance of the lining material from each set to the same exposure conditions. Such variations in swelling behavior can help explain why some pipe sections experienced lining failures while others did not.

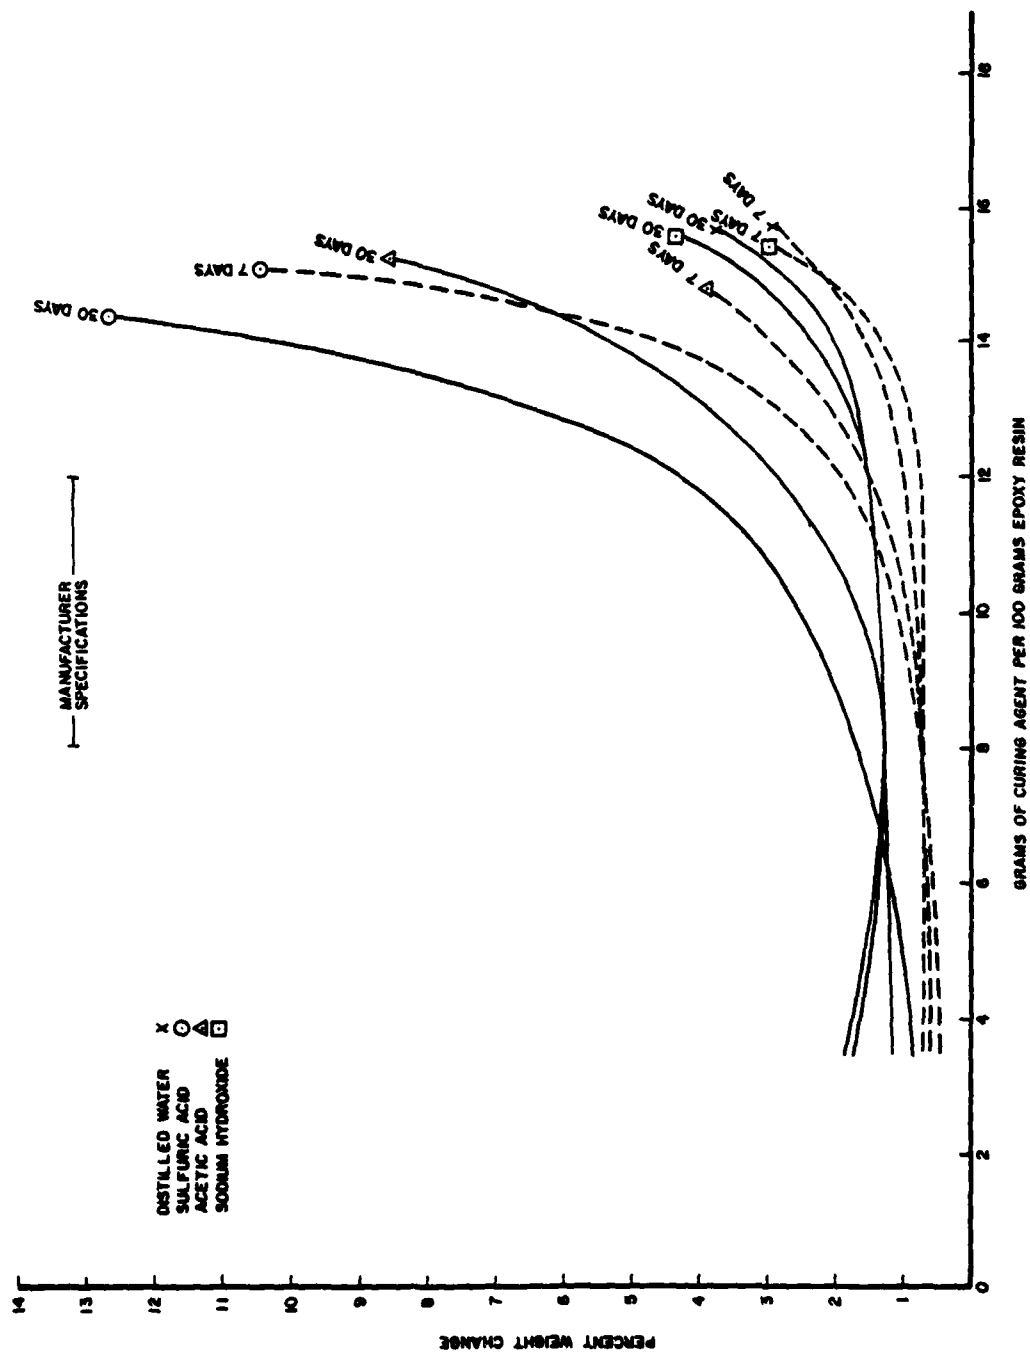
Figure 3. Weight gain versus curing agent (DTA) concentration.

It is clear from these studies that off-proportion mixing of epoxy resin and curing agent can cause large amounts of swelling. If the materials for lining each section of pipe are mixed by batch, or if a machine mixer is used and is turned off between lining application in each section of pipe, the concentration of curing agent in the lining may vary. Even relatively

small variations in curing agent can cause large changes in swelling, which both weaken the lining material and cause dimensional changes that could lead to failure.

ments of not more than 0.5 percent weight gain after 7 days, or more than 0.9 percent weight gain after 30 days. Off-proportion curing agent was the probable cause of excessive weight gain.

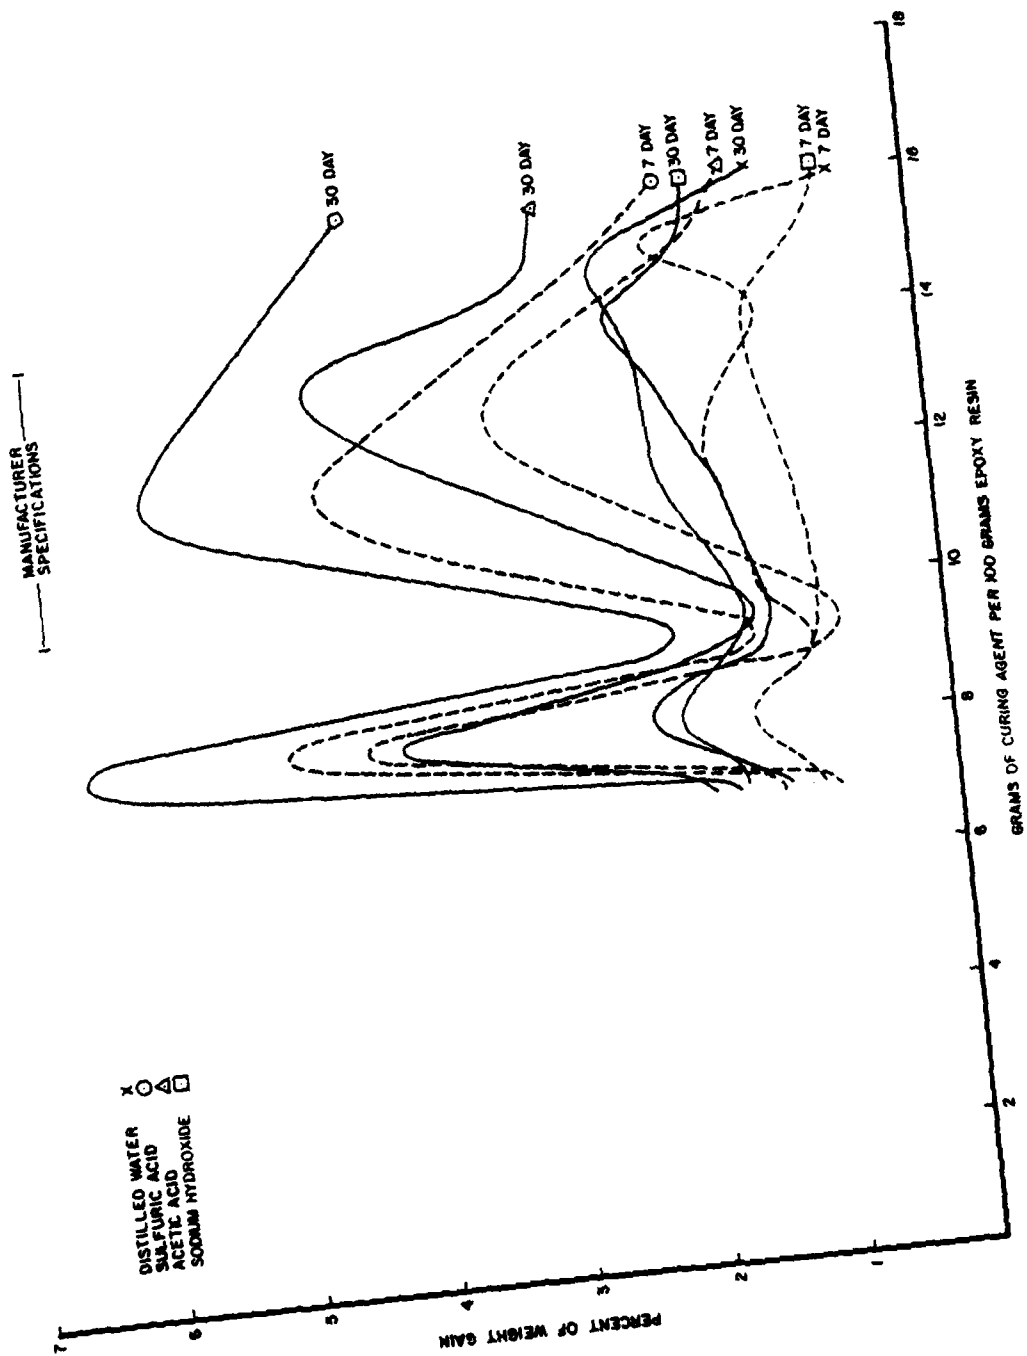
Figure 4. Weight gain versus curing agent (TETA) concentration.
